**Flood Control Project Maintenance  
Levee Inspections**

**Fall 2011 Levee Maintenance Deficiency Summary Report**

**Sacramento River Basin**

**Reclamation District No. 0150 Merrit Island**

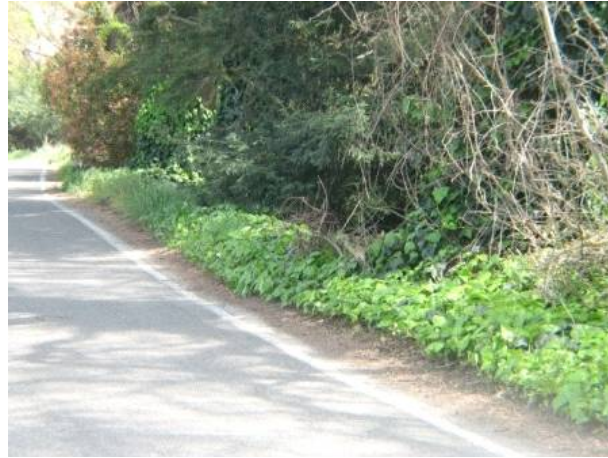
Levee Mile Report Line	63
Start Levee Mile	6.87
End Levee Mile	6.95
Location	Land Side
Category	Earthen Levee
Item	Encroachments
Landscaping on landward slope blocking view from LM 6.87 to 6.95	
pkazi_f_20110923_342.jpg

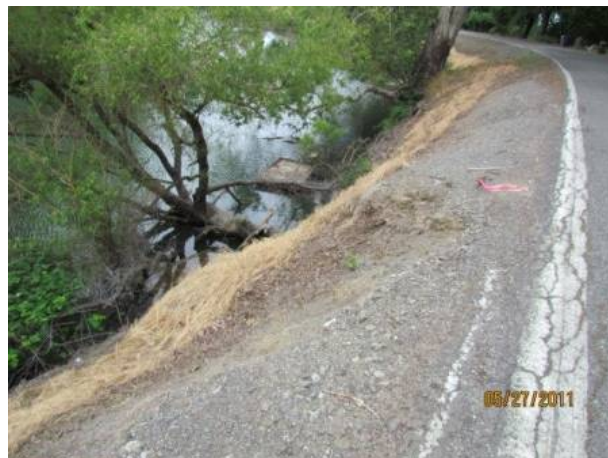
Levee Mile Report Line	66
Start Levee Mile	7.02
End Levee Mile	7.02
Location	Water Side
Category	Earthen Levee
Item	Erosion / Bank Caving
Updated erosion site picture on the waterside slope of the levee looking upstream during Spring 2011 inspection.	
pkazi_f_20110923_370.jpg

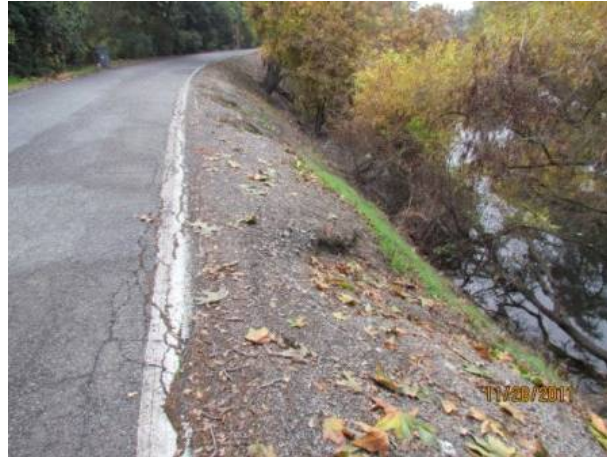
Erosion was found on the waterside of the levee looking downstream. This picture was taken during fall 2011 inspection.

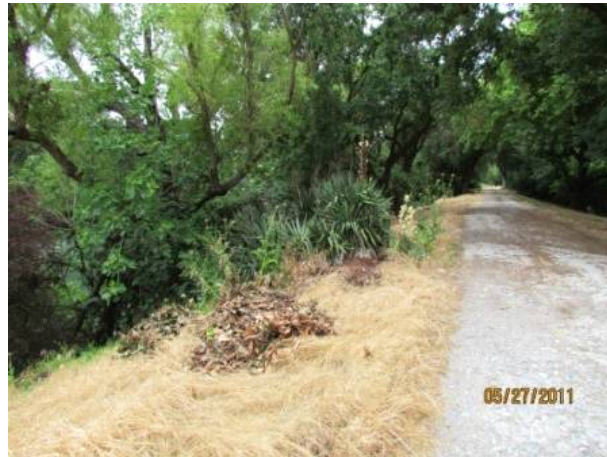
pkazi\_f\_20110923\_373.jpg

Landscaping on the waterside of the levee. The picture was taken from the crown looking upstream.

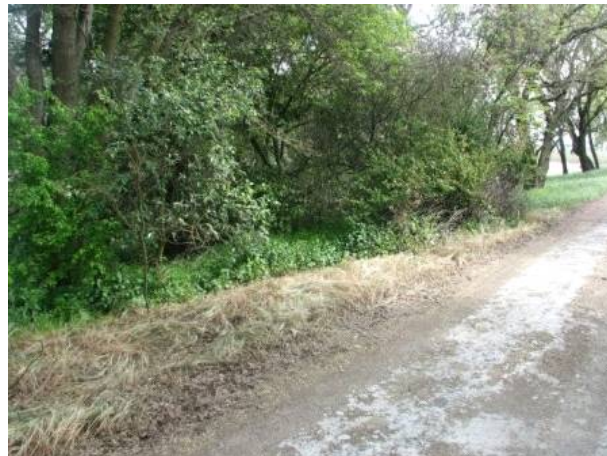
Levee Mile Report Line	70
Start Levee Mile	7.42
End Levee Mile	7.47
Location	Land Side
Category	Earthen Levee
Item	Encroachments

Landscaping on landward slope blocking view from LM 7.42 to 7.47

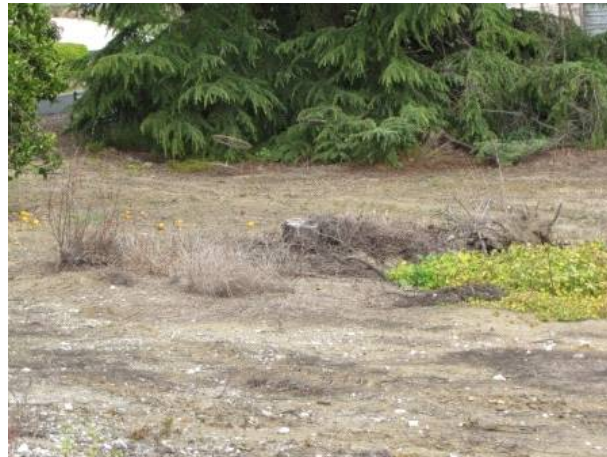
Levee Mile Report Line	72
Start Levee Mile	7.50
End Levee Mile	7.50
Location	Land Side
Category	Earthen Levee
Item	Trim / Thin Trees
View of a tree stump on the landward slope.	
pkazi_f_20110923_372.jpg

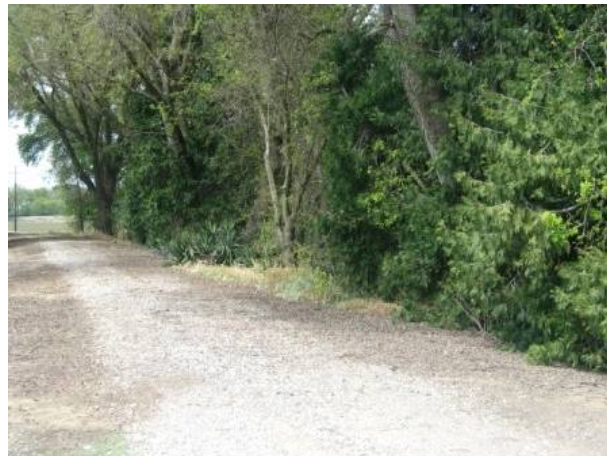
Levee Mile Report Line	73
Start Levee Mile	7.55
End Levee Mile	7.55
Location	Land Side
Category	Earthen Levee
Item	Encroachments
Landscaping on landward slope blocking view from LM 7.52 to 7.58	
pkazi_f_20110923_345.jpg

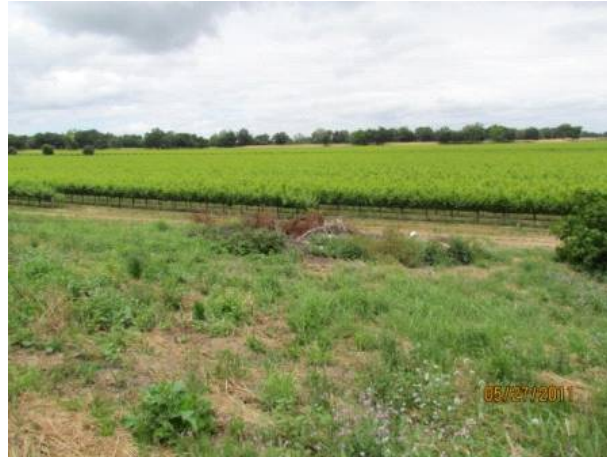
pkazi\_f\_20110923\_382.jpg

Prunings located on the toe of landward side of the levee. The picture was taken from the crown looking upstream.

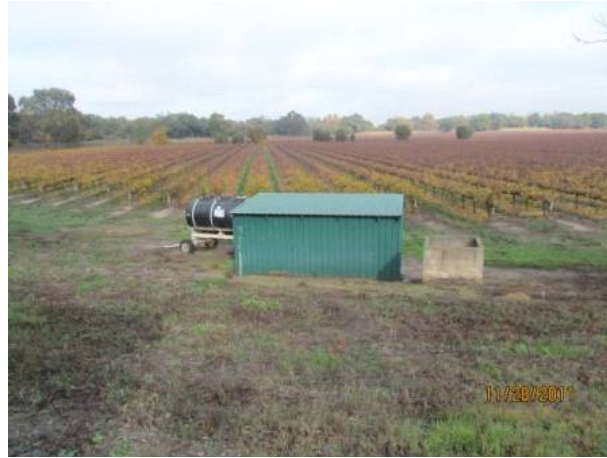
pkazi\_f\_20111208\_423.jpg

Equipment was found on the landside of the levee looking upstream.

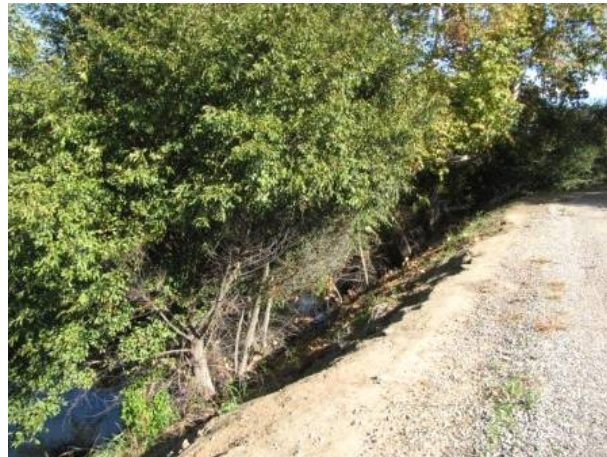
Levee Mile Report Line	79
Start Levee Mile	8.21
End Levee Mile	8.21
Location	Water Side
Category	Earthen Levee
Item	Erosion / Bank Caving

View of erosion occurring along the waterward slope.

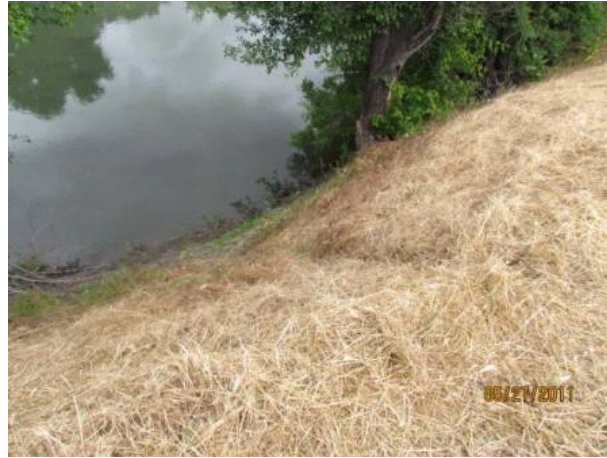
pkazi\_f\_20110923\_375.jpg

Slope instability on the waterside slope of the levee. The picture was taken from the crown looking upstream.

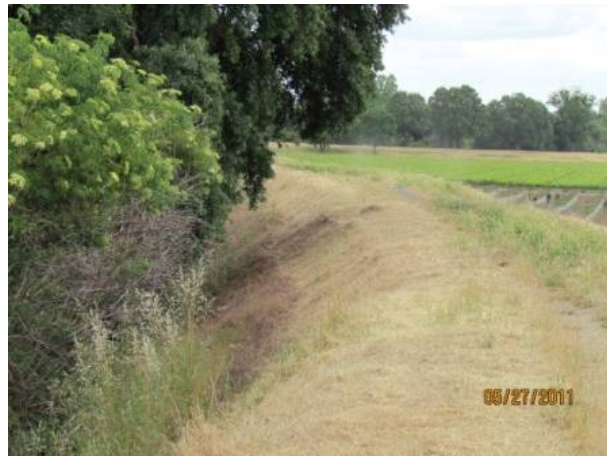
pkazi\_f\_20110923\_322.jpg

Erosion was found on the waterside slope of the levee. The picture was taken from the crown looking downstream.

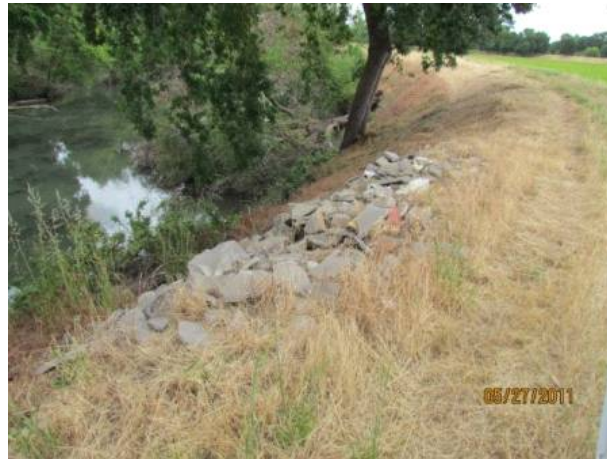
pkazi\_f\_20110923\_323.jpg

Broken concrete pipe was left on the waterside slope of the levee. The picture was taken from the crown looking upstream.

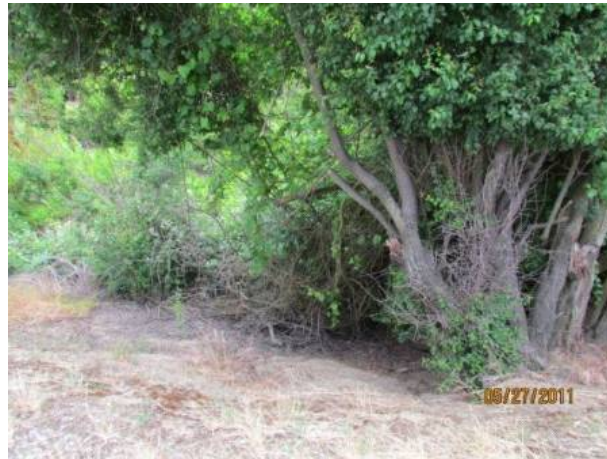
Levee Mile Report Line	88
Start Levee Mile	9.35
End Levee Mile	9.35
Location	Water Side
Category	Earthen Levee
Item	Trim / Thin Trees

Trees needed to be trimmed for visibility of the waterside slope of the levee. The picture was taken from the crown looking towards the slough.

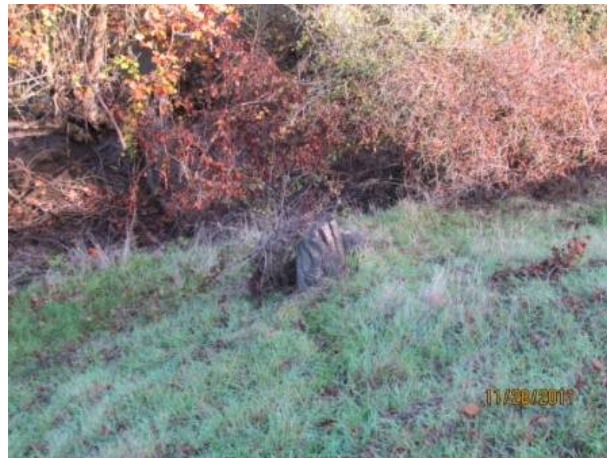
Levee Mile Report Line	89
Start Levee Mile	9.38
End Levee Mile	9.38
Location	Water Side
Category	Earthen Levee
Item	Trim / Thin Trees

A tree stump was found on the waterside of the levee looking upstream.
